A Summary of a NIOSH fire fighter fatality investigation

June 1, 2004

Career Firefighter Dies from Injuries Received during a Chimney and Structural Collapse after a House Fire - Pennsylvania

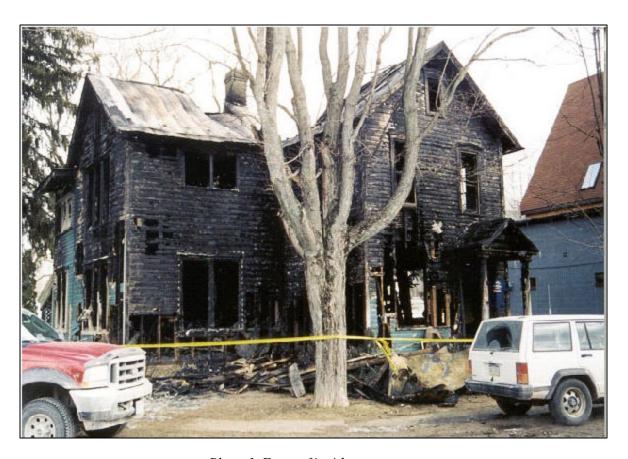
The incident structure was a balloon-frame constructed, two-story, single-family residence built in the 1890s (Photos 1&2). Each floor had approximately 980 square feet of furnished living area, with a 980 square foot unfinished basement. The first floor had a living room, dining room and kitchen. There was a 60 square foot covered back porch at the rear of the structure. The second floor had several bedrooms. Exterior construction was wood clapboards over rough timber framing. The roof consisted of tin sheeting and the house set on a 70x100 foot level lot. Interior construction was plaster over wood lathe. Over the years, remodeling had concealed an interior brick chimney that was no longer in use. The chimney had been removed below the roof line and was not visible from the exterior.

Photo 1. Front of incident structure

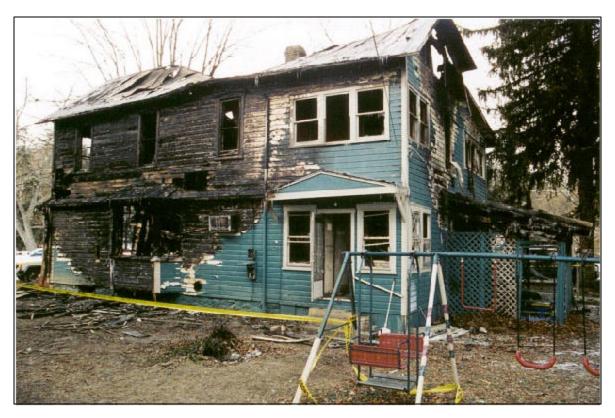
Photo 2. Rear of incident structure

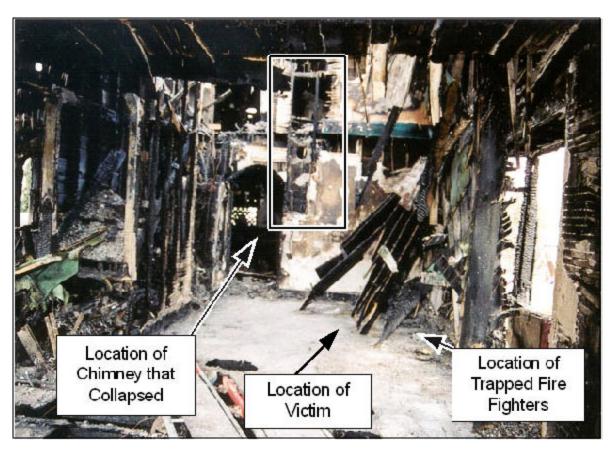
At the same time that the Deputy Chief and fire fighter were on the second floor, the victim and two fire fighters were working underneath on the ground floor. They did not hear the Deputy Chief's warnings about the impending collapse. The fire fighters were located against the southern exterior living room wall when the ceiling and chimney collapsed on them at 1705 hours (Diagram and Photo 3). The victim was

Photo 3. Site of structural collapse in living room after debris removal

> Discussion: Due to the destructive powers of fire, most structures that have been involved in fires are structurally weakened. Analysis of the exterior of the structure should be performed continuously while conducting interior operations. Similarly, before overhaul operations are begun, the structure should be determined safe to work in by the IC and a designated Safety Officer. If necessary, the IC should seek the help of qualified structural experts to assess the need for the removal of dangerously weakened construction, or should make provisions for shoring up load-bearing walls, floors, ceilings, roofs, or as in this case, a brick chimney. In this incident, had a thorough assessment been made of the structure, including the chimney, overhaul could have been delayed until the area around the chimney had been demolished or stabilized.

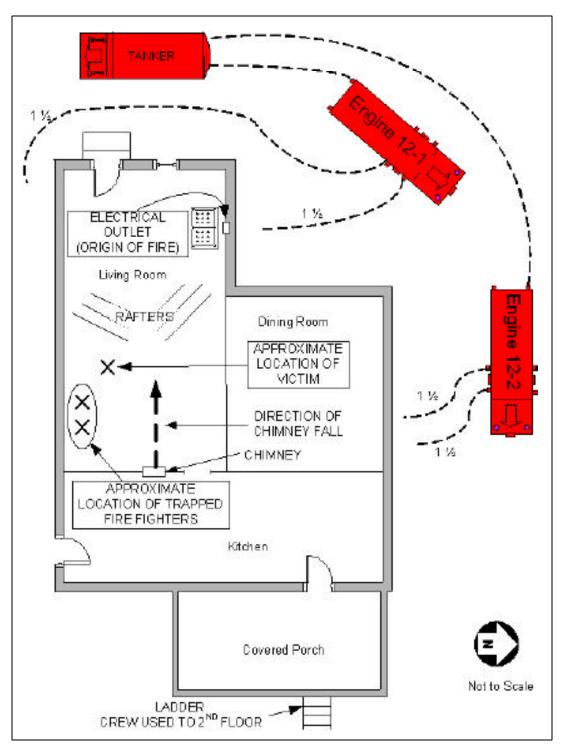
Diagram. Aerial view of incident scene showing area of collapse on 1st floor
